GEOPHYSICAL SURVEY - GRAVE
DETECTION/DELINEATION BENEATH PAVED
PARKING LOT

**Final Report
Geophysical Survey
Grave Detection/Delineation Beneath Paved Parking Lot
~200' x 400' Area (estimated ½-city block)
Queen Lane Apartments Site
Philadelphia, PA
Enviroscan Reference Number 031236a**

**Prepared For: CHRS, Inc.
Prepared By: Enviroscan, Inc.
May 11, 2012**

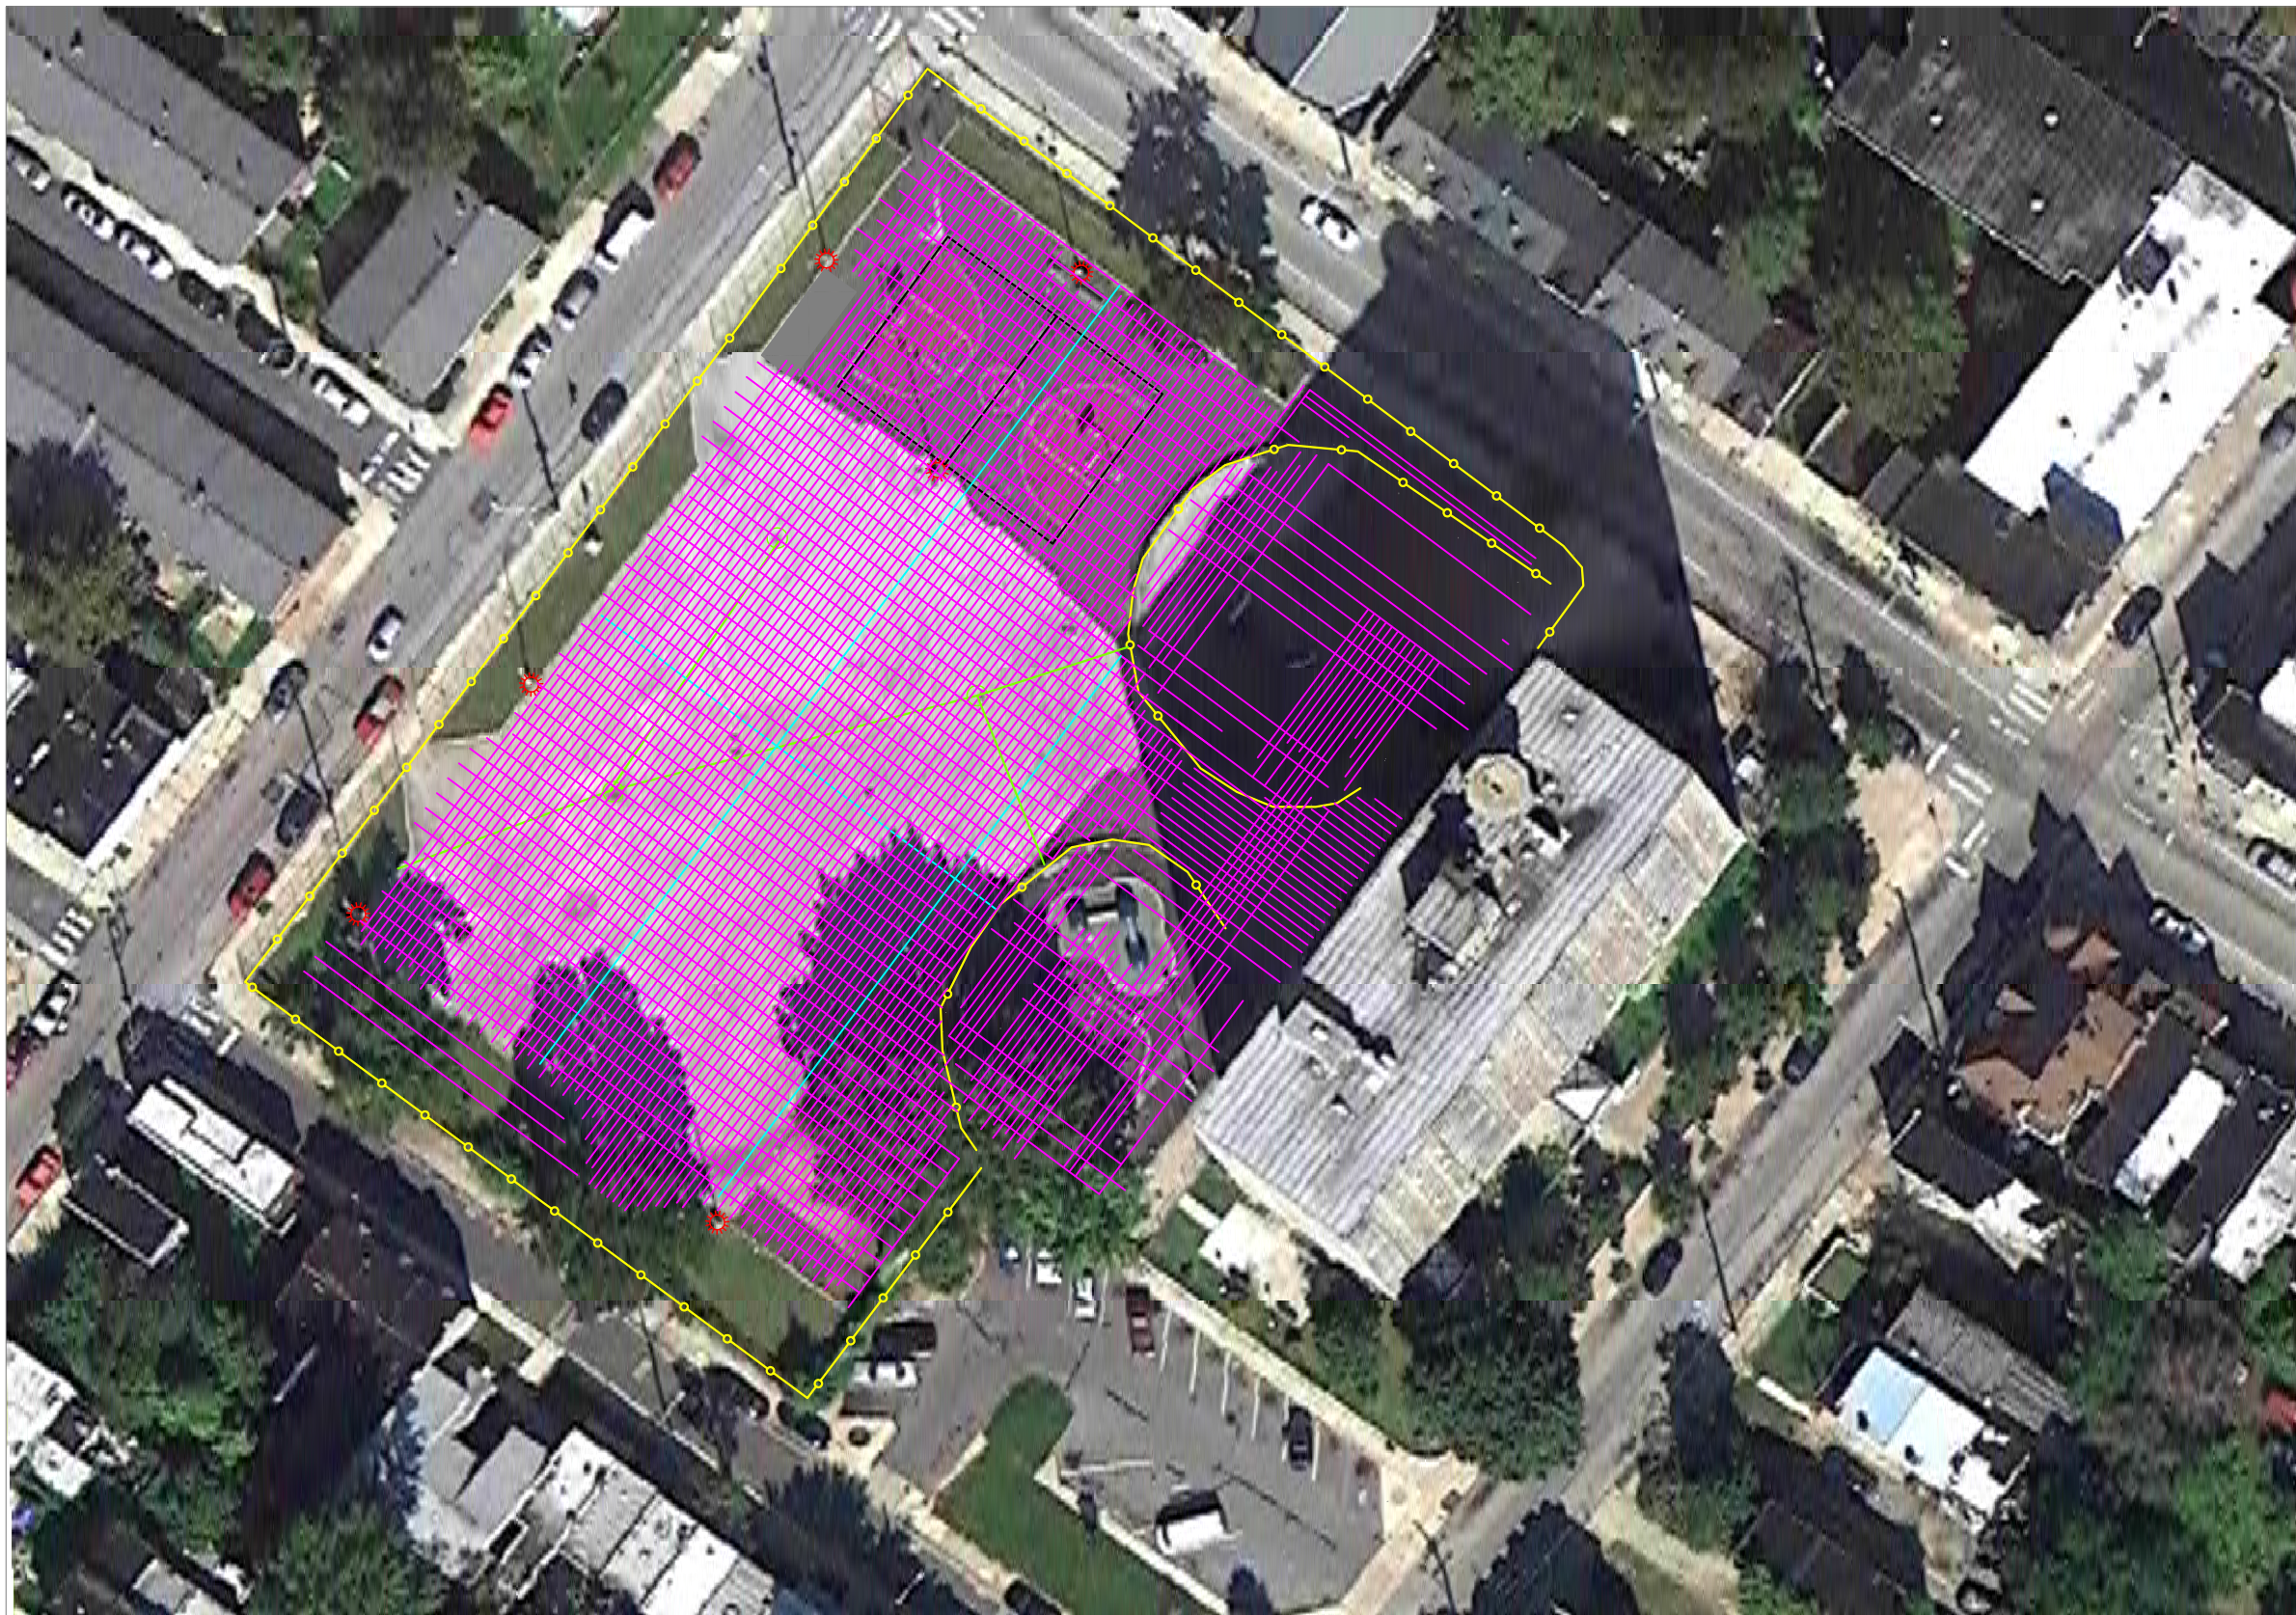
GPR Survey Layout

Enviroscan performed GPR scanning of the survey area using a GSSI SIR-2000 GPR controller with an internal hard drive and color display, along with a 500 MHz scanning antenna with an optical survey wheel for accurate scanning distance control. The survey areas were scanned along an orthogonal grid of profiles spaced two feet apart north to south and 5 feet apart east to west (see magenta lines on Figure 1). Note that some lines are discontinuous due to the presence of trees, walls, fencing, playground equipment, and other obstructions. The location of numerous grid points and nearby site surface features were recorded with a Topcon Hyperlite RTK survey grade GPS system. Several observed storm pipes were imaged with GPR to calibrate the depth estimations.

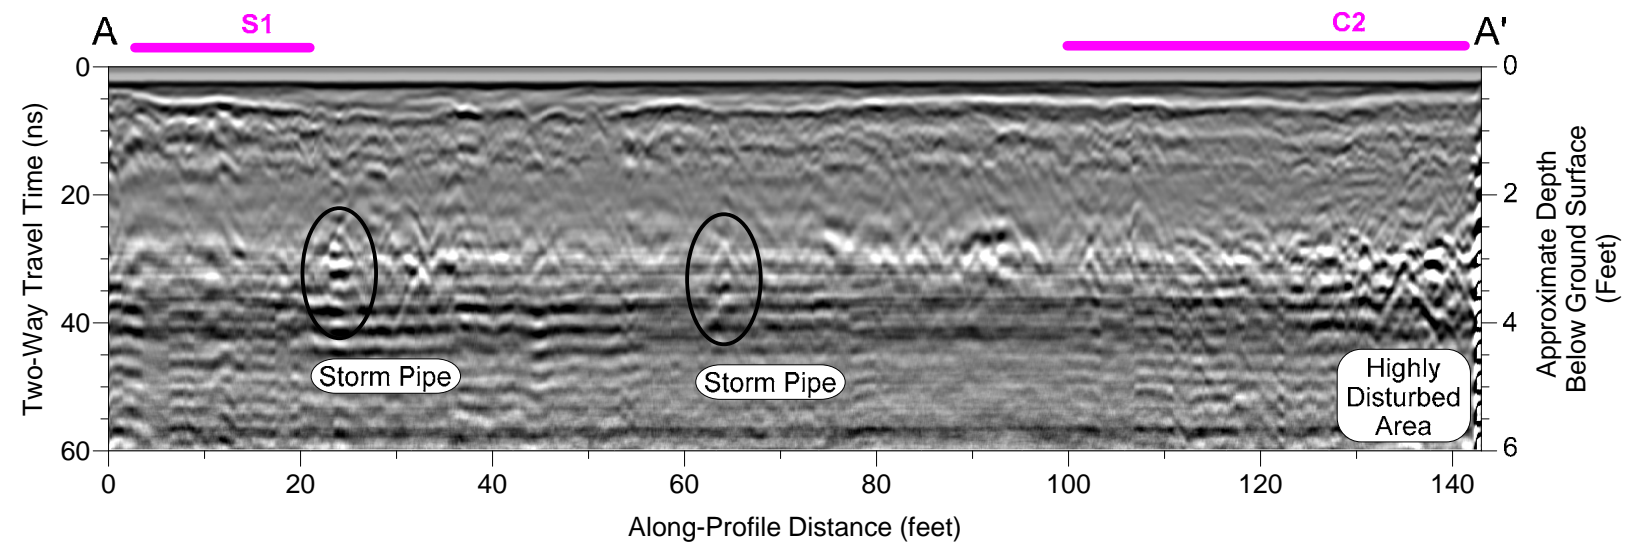
Figure 4 displays three representative raw GPR images from three selected grid lines. Please note that a raw GPR profile represents a vertical slice (cross section) through the ground, such that the top of the profile is the ground surface. The locations of these grid profiles are shown in light blue lines labeled A-A’, B-B’, and C-C’ on Figure 3. GPR anomalies of interest on both Figures 3 and 4 are also numbered, i.e. S1, C1, for clarity in comparing the two types of data in different figures (raw GPR profile vs. processed GPR slices).

Several features on the cross section are noted for better understanding of the profile image. Features S1, S2, C1, and C2 appear as highly disturbed areas starting at a depth of 2.5 to 3 feet below ground surface. Feature C1 also displays historic settling of soil near the surface (see yellow line), as evidenced by the depression of the near surface reflectors. This is common for excavations when the fill material decomposes over time, such as a covered pit filled with tree stumps. Anomaly C2 is within the suspected boundaries of the cemetery; however, it is also within a reasonable range of the high rise to have been influenced by construction activities. The depth of Anomaly C2 is similar in depth to the other anomalies that are reasonably far away from the high-rise to be categorized as historic or non-construction-related. Anomaly C2 should be further investigated as an anomaly of interest for the cemetery. Anomaly C1 is not within the suspected boundaries of the cemetery; however, it is also not near the historic building locations on the south side of the block. Anomaly C1 should also be further investigated as a possible cemetery-related anomaly. The remaining “S” labeled anomalies are roughly coincident with historic house locations on this block.
